GREEN BAY AREA PUBLIC SCHOOL DISTRICT

Facilities Master Planning Update: Facilities Study Report

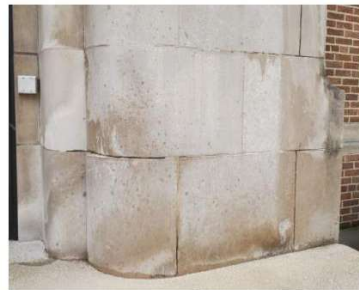
- Original 1939 building stone caps at top of walls - joint sealant is hard, cracked in some places. Top of stone is moldy in some areas. Stone caps and joints are allowing water infiltration into exterior wall. Recommend capping with continuous prefinished metal coping (as has been

done on LMC wing) in lieu of recaulking. (Custodian indicated that 1990 building caps had just been caulked, or recommendation would be to put prefinished metal coping on that building too).

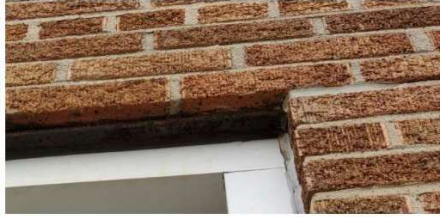
- **Stone** areas and bands are stained/moldy and should be cleaned. Some stone areas need to be tuckpointed.
- Original building window **lintels** are rusting into the thickness of the metal. Rust should be removed and lintels painted to protect from further deterioration.

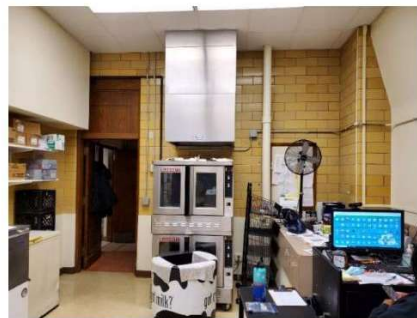
- **Lockers** in the 1939 building and first floor of 1990 building are in poor condition and should be replaced.
- **Kitchen:** The kitchen area is small, space is lost due to original mechanical chase projections, per food service director should be remodeled, incorporating some adjacent space to allow for better layout and new cooler.

- Food Preparation and Satelliting from ASB's Production Kitchen per Owner
 - Provide new, expanded kitchen including walk-in cooler.

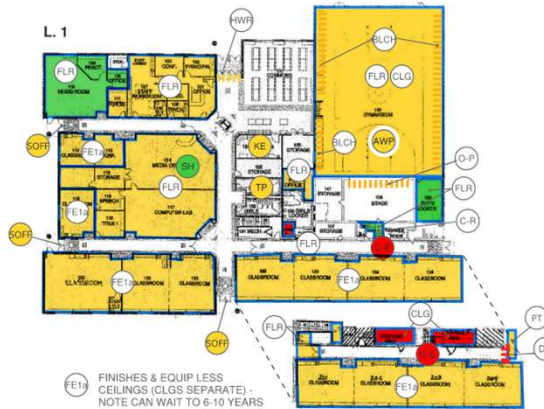
- 1 ALL EXTERIOR ALUM DOORS ARE SINGLE GLAZED - REPLACE W/ INS GLASS (LOW PRIORITY DUE TO VESTIBULES)
- 2 REMOVE AC UNITS IN WDWs AND REPLACE WITH INS GLASS
- 3 REPLACE CRACKED / MISSING CAULK AT EXT CJ'S, LOUVERS, SOME WDWs
- 4 REPLACE WIRE GLASS AT INTERIOR DOORS / SIDELIGHTS WITH TEMPERED GLASS
- 5 REPLACE CEILINGs ENTIRE BUILDING DUE TO CONDITION AND FOR REQ MECH UPGRADES
- 6 PAINT EXTERIOR WINDOW LINTELS

- (FLR) REPLACE FLOORING
- (ACT) ACT REPLACEMENT
- (CLG) CEILING REPLACEMENT
- (CODE) CODE - ELEVATOR - NO CURRENT ACCESSIBLE ROUTE TO L2
- (BLCH) BLEACHERS REPLACEMENT
- (AWP) INSTALL ACOUSTICAL WALL PANELS
- (FE1a) FINISHES & EQUIP LESS CEILINGs (CLGS SEPARATE) - NOTE CAN WAIT TO 6-10 YEARS IF NOT DOING DISPLACEMENT VENTILATION SYSTEM
- (C-R) CODE - REPLACE / REPAIR HANDRAILS / GUARDS
- (HWR) REVISE HARDWARE FOR SECURE ENTRY
- (DR) REPLACE DOOR/FRAME
- (O-P) REPLACE CURTAIN WITH OPERABLE PARTITION
- (KE) KITCHEN EQUIPMENT

- (SH) REPLACE LIBRARY SHELVING IN 6-10 YEARS
- (TP) REPLACE TOILET PARTITIONS
- (SOFT) REPLACE DETERIORATING EXG GGD SOFFITS WITH METAL SOFFIT PANELS
- (PT) PAINT EXTERIOR STAIRS

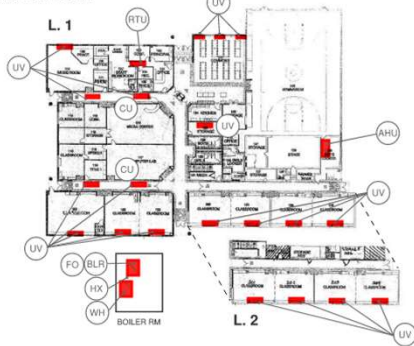
- (UV) Remove Unit Ventilators and window A/C units and incorporate room into new HVAC system
- (RTU) Replace Rooftop Unit
- (AHU) Replace Gym AHU, provide better distribution of air
- (CU) Remove Condensing Unit with Unit Ventilator
- (BLR) Replace Boiler Plant with new plant (Geo or Propane BLR) New Hot Water Systems
- (WH) Replace Water Heater Tank, connect to new BLR plant
- (HX) Remove Heat Exchanger when Hot Water Pumps are replaced
- (FO) Remove Fuel Oil Tank

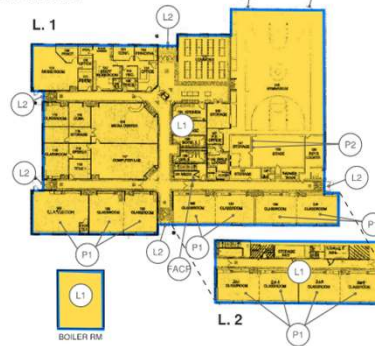
- (L1) REPLACE FLUORESCENT LIGHTS WITH LED FIXTURES IN 6-10 YEARS.
- (L2) REPLACE EXTERIOR HID LIGHTS WITH LED FIXTURES IN 6-10 YEARS.
- (FAC) REPLACE WITH VOICE EVACUATION SYSTEM IF REMODELLING MORE THAN 10% OF BUILDING
- (P1) ADD AN ADDITIONAL POWER CIRCUIT IN EACH CLASSROOM
- (P2) PANEL MANUFACTURER NO LONGER IN BUSINESS/PARTS NOT AVAILABLE
