GREEN BAY AREA PUBLIC SCHOOL DISTRICT

Facilities Master Planning Update: Facilities Study Report

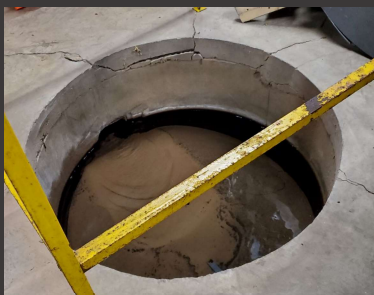
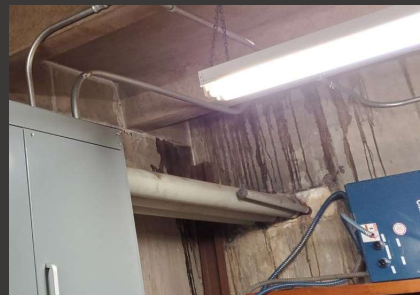
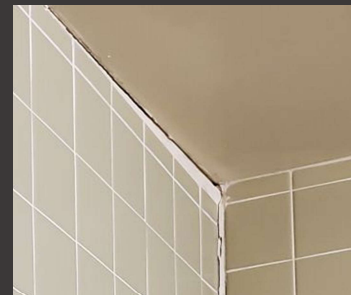
- Recommended to be demolished
 - Several conditions not possible to correct
 - Building Demolition Cost is included in the assessment
